Canopy® Software Release 8.2.2

Software Release Notes

CAN822-SRN-en

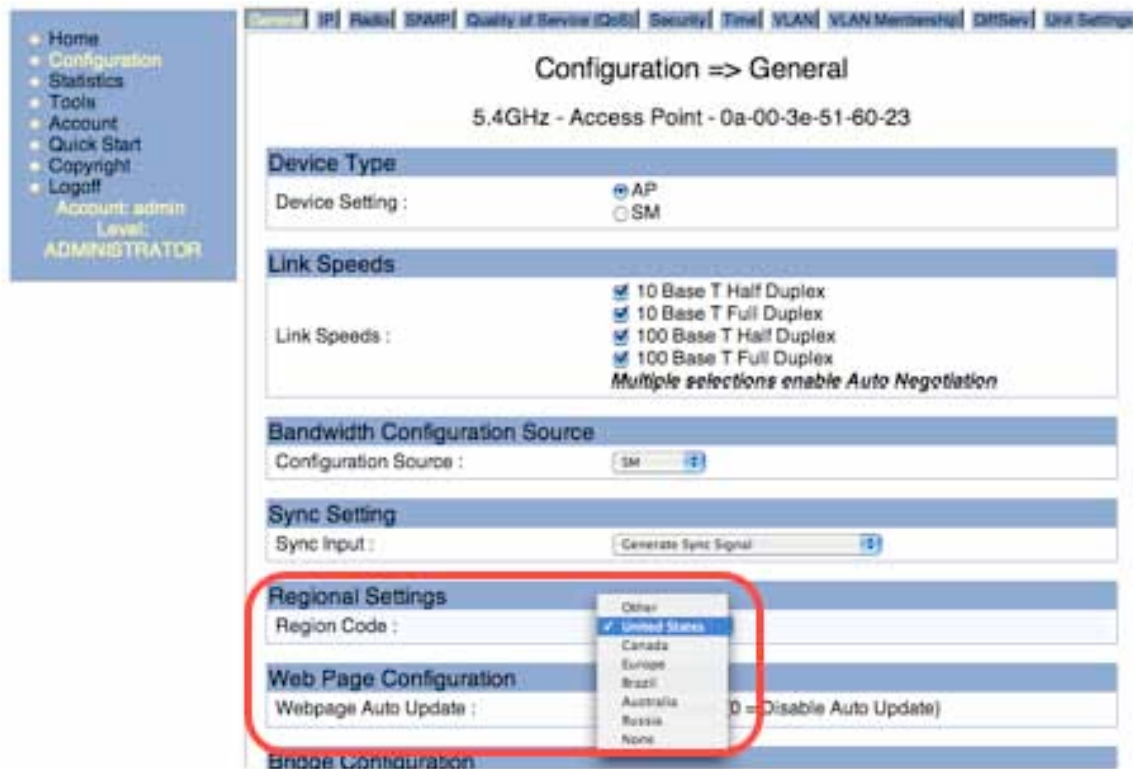
Figure 3: Region Code on AP Configuration => General page

All modules running Release 8.2 display a Region Code pop-up on the Configuration => General page, as shown in Figure 3.

Operators in regions outside the US and Europe especially should confirm the Region Code after an upgrade, as it will be set to Europe or US, depending on the frequency band. Although the module will function with the incorrect Region Code, the best practice is to set it correctly after the Release 8.2 upgrade, as features in future releases may use the Region Code.

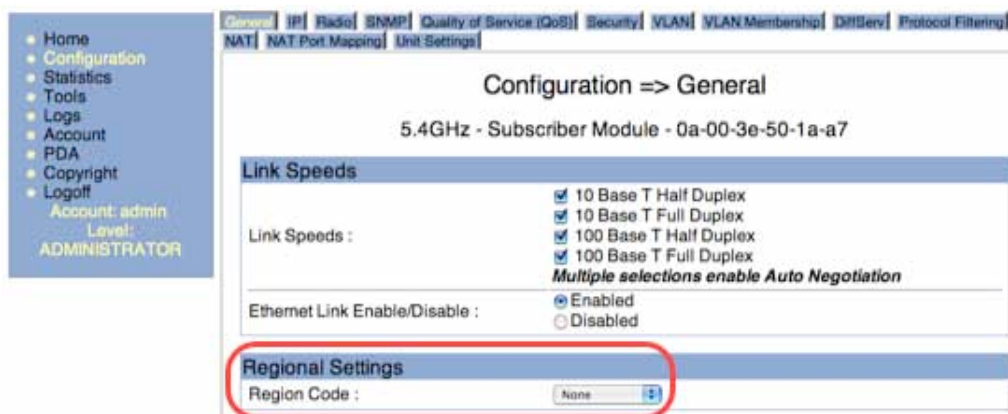
Figure 4: Configured Region Code on SM Configuration => General page

An SM or BHS has both a configurable Region Code and, once it registers to an AP or BHM, an active Region Code. If an SM or BHS registers to an AP or BHM running Release 8.2 or later, it uses the Region of the AP or BHM to determine its DFS behavior and displays the AP's or BHM's Region Code on its Home => General Status page, as shown in Figure 5. If the SM or BHS registers to an AP or BHM running a release prior to Release 8.2, it uses its configured Region Code from its Configuration => General page, as shown in Figure 4. The active Region Code determines the DFS behavior.

The two Region Codes should be the same in normal operation, but will not be the same if, for example, as shown in Figure 4 and Figure 5, an SM configured with a Region Code of "None" has registered to a Release 8.2 AP with a Region Code of Europe.
