Canopy[®] Software Release 8.2.4

Software Release Notes

CAN824-SRN-en Issue 1

March 2008

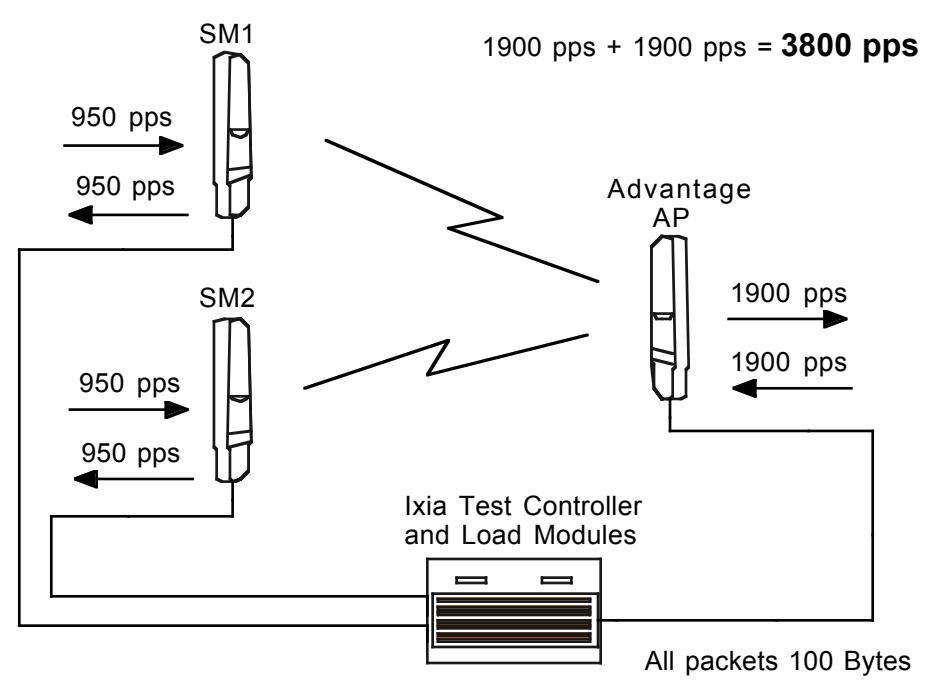
Figure 7: Test Setup and Results

The benchmark system is composed of 2 SMs and 1 Advantage AP, as shown in Figure 7. Traffic generation and measurement equipment is connected to both SMs and the AP. Traffic is generated such that any one packet attempts to traverse an SM and then the AP, or the AP and then an SM. No SM to SM traffic is included in the benchmark. RF conditions are maintained such that all links run in 2X mode.

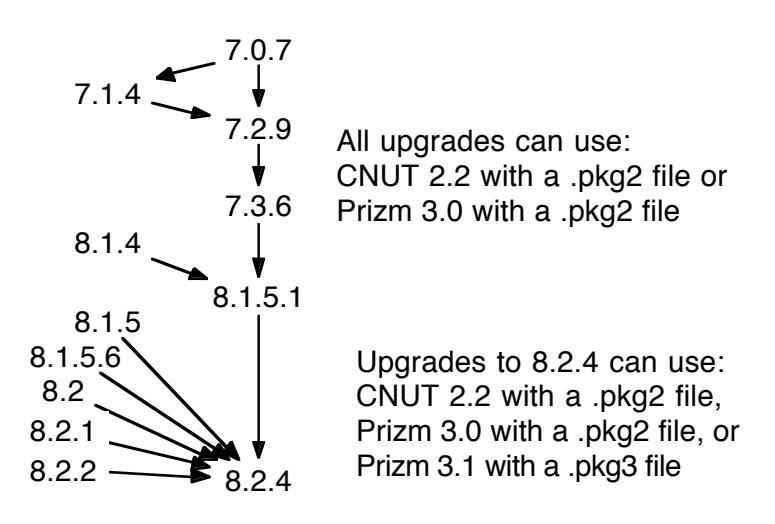
Figure 8: Supported Upgrades

Modules and sectors running Releases prior to Release 8.1.5 should first be upgraded to Release 8.1.5.1, following the upgrade path shown in Figure 8. For details on upgrading to Release 8.1.5.1, please see the Release 8.1.5.1 Release Notes available on the Canopy web site at http://motorola.canopywireless.com/support/software under Canopy System Software.
